Evaluation of the FAA Design Procedures for High Traffic Volume Pavements

Starr Kohn

Geotechnical Laboratory
DEPARTMENT OF THE ARMY
Waterways Experiment Station
Corps of Engineers
Vicksburg, Mississippi 39180

October 1985

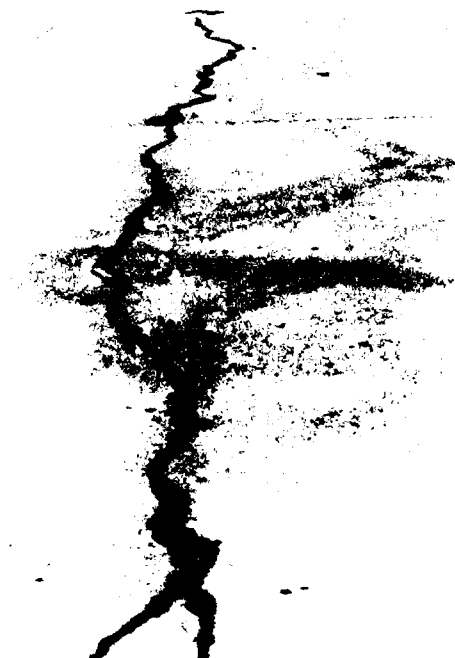
Figure 6. Medium-severity cracking in
section 14

Overall, there were no special conditions at DFW which would affect the evaluation of the pavements with the exception of sections 13 and 14. These two sections were both located on the approaches to the bridges used to connect the east and west side of the airport. Both sections have had major maintenance in the form of slab-jacking performed in localized areas. This maintenance was performed in areas where the fill over a drainage line had consolidated causing the slabs to settle and crack. Figures 6 and 7 show the major cracks present in these areas.

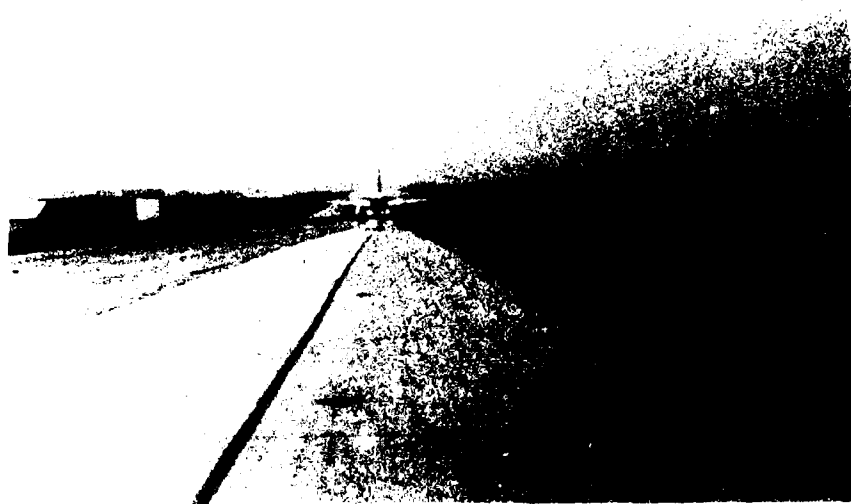
It should be noted that the major distress found at ATL was spalling of the joints. This spalling was located on the longitudinal joints which are keyed. It was observed that several sections had already received patching to repair the spalling, and in some areas these patches were starting to spall again. The overall condition of the pavements was very good with an average PCI of 81.7 and a standard deviation of 3.8. Figures 9, 10, and 11 are representative photographs of the conditions at ATL.

Figure 11. General view of section 16
(Note: The B-767's main gear rides the
longitudinal joint)

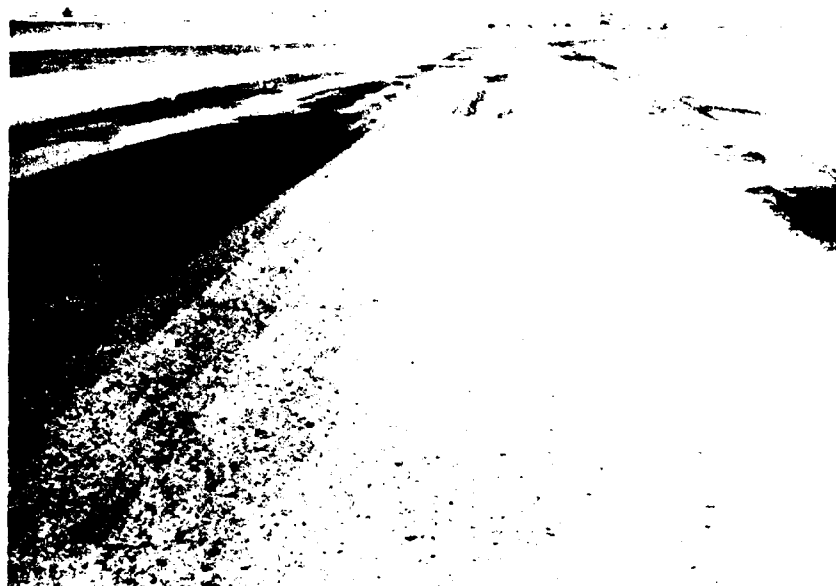
The condition of the pavements at PHX ranged from poor to excellent with an average PCI of 55.4 and standard deviation of 20.5. This large range is due in part to the range in the age of the pavements at PHX (4 to 16 years). Two major problems were noted with the pavements at PHX. The first problem is that older pavements are exhibiting fatigue cracking of the AC surface. No rutting was noted in these areas; however, the cracking was of medium severity. This condition is most likely caused by the synergistic effects of load, aging of the asphaltic material, and the severe climate of Arizona (dramatic temperature variations between night and day). Figure 13 shows the alligator cracking in section 8. The second problem was that the newer pavements were observed to be bleeding excessively. This problem appeared to be caused by a higher than normal asphalt content in the surface material. This was orally reported by Phoenix materials engineering personnel. The AC content of the material was about 1 percent higher than normally used in the area. Figure 14 shows the rutting and bleeding occurring in section 1, and Figure 15 shows the bleeding in section 5.

Figure 15. Bleeding in section 5

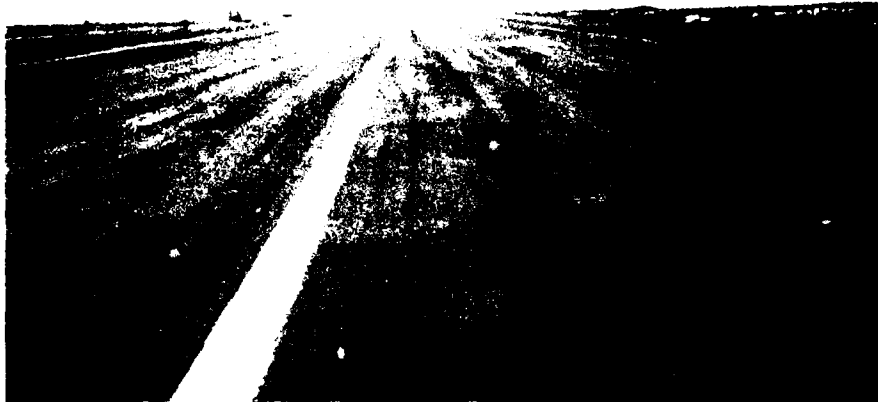
Figure 17. General view of section 2

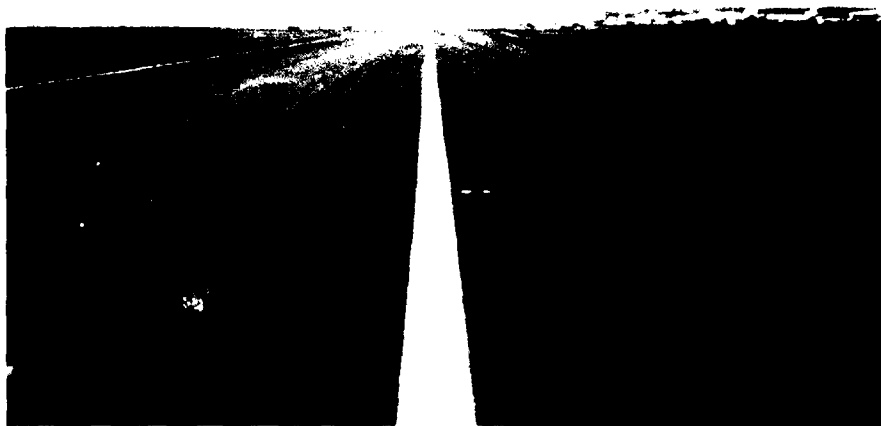
Figure 19. Overall view of section 3
